# Honda Accord LX Broadside Collision With a Narrow Fixed-Object: FOIL Test Number 97S006

PUBLICATION NO. FHWA-RD-98-011

JANUARY 1998

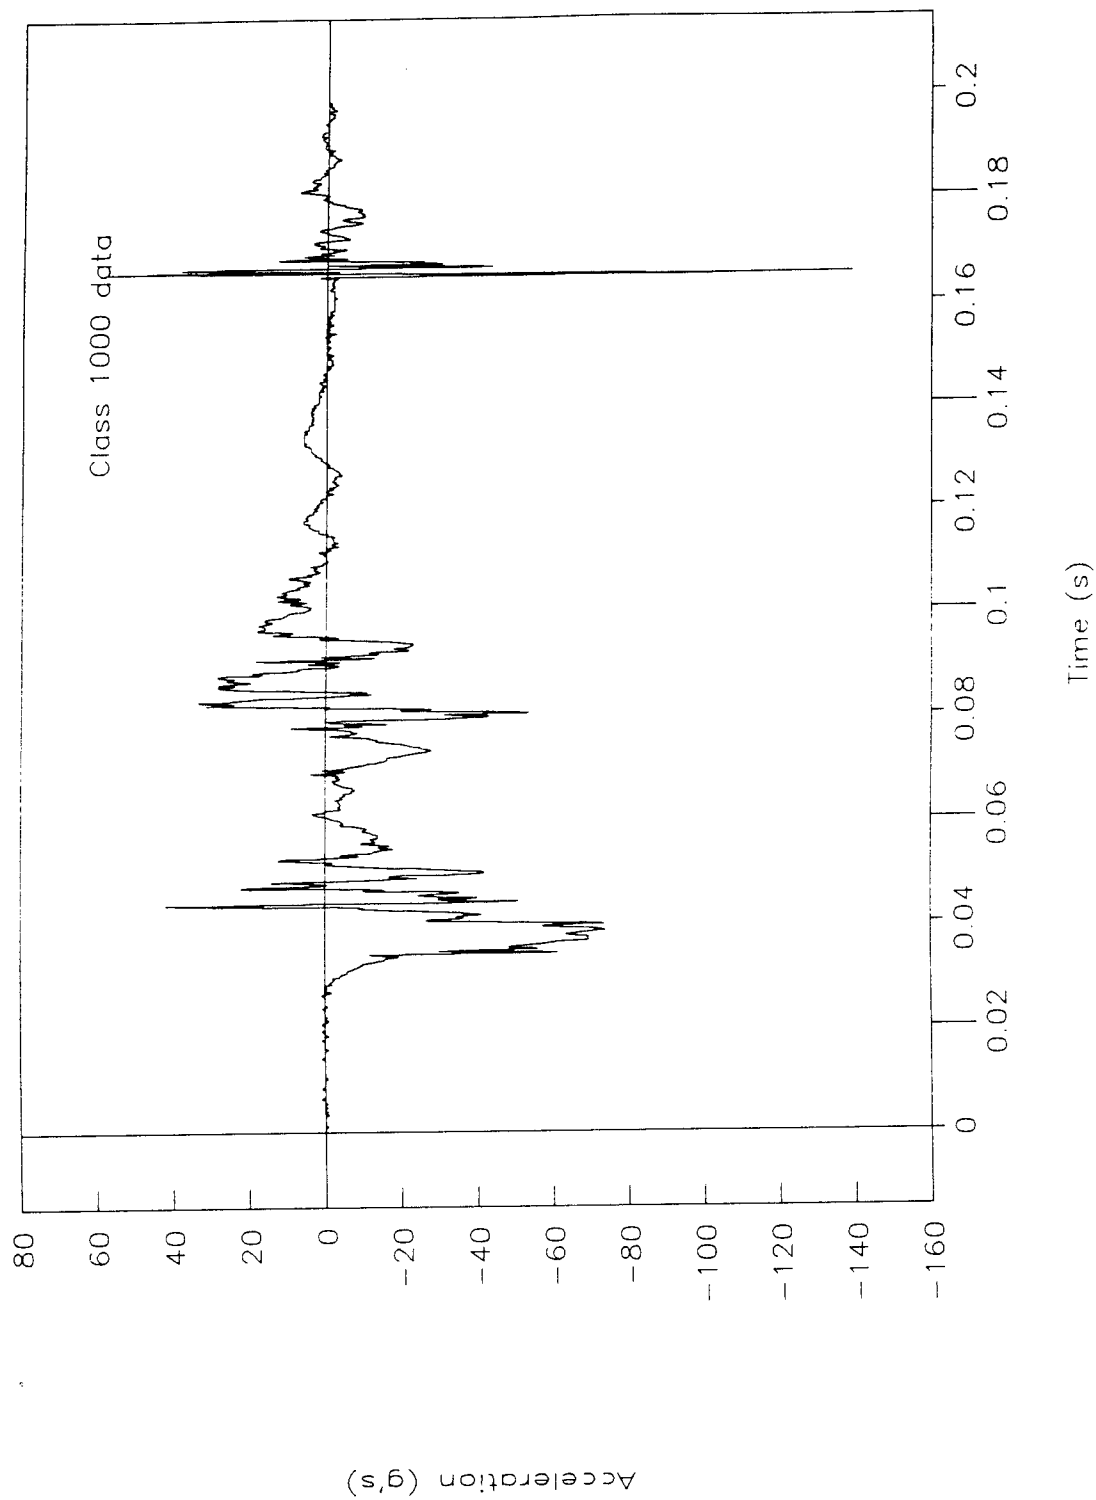
Figure 30. Acceleration vs. time, redundant upper rib, test 97S006.

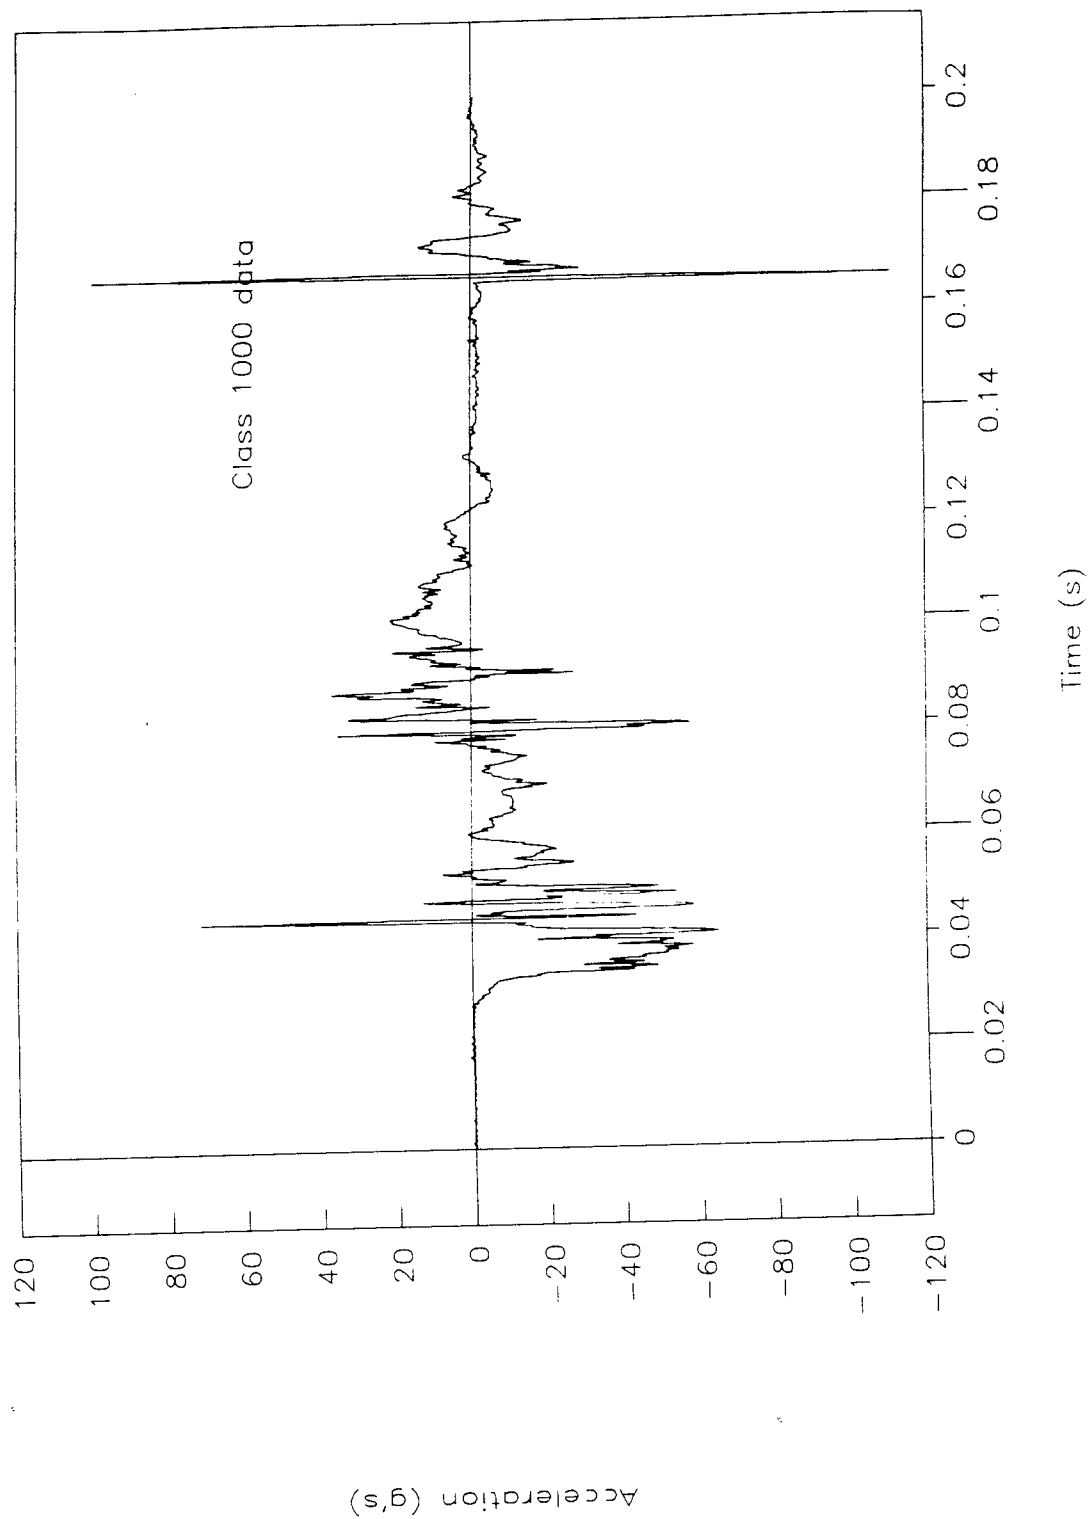
Figure 31. Acceleration vs. time, primary lower rib, test 97S006.

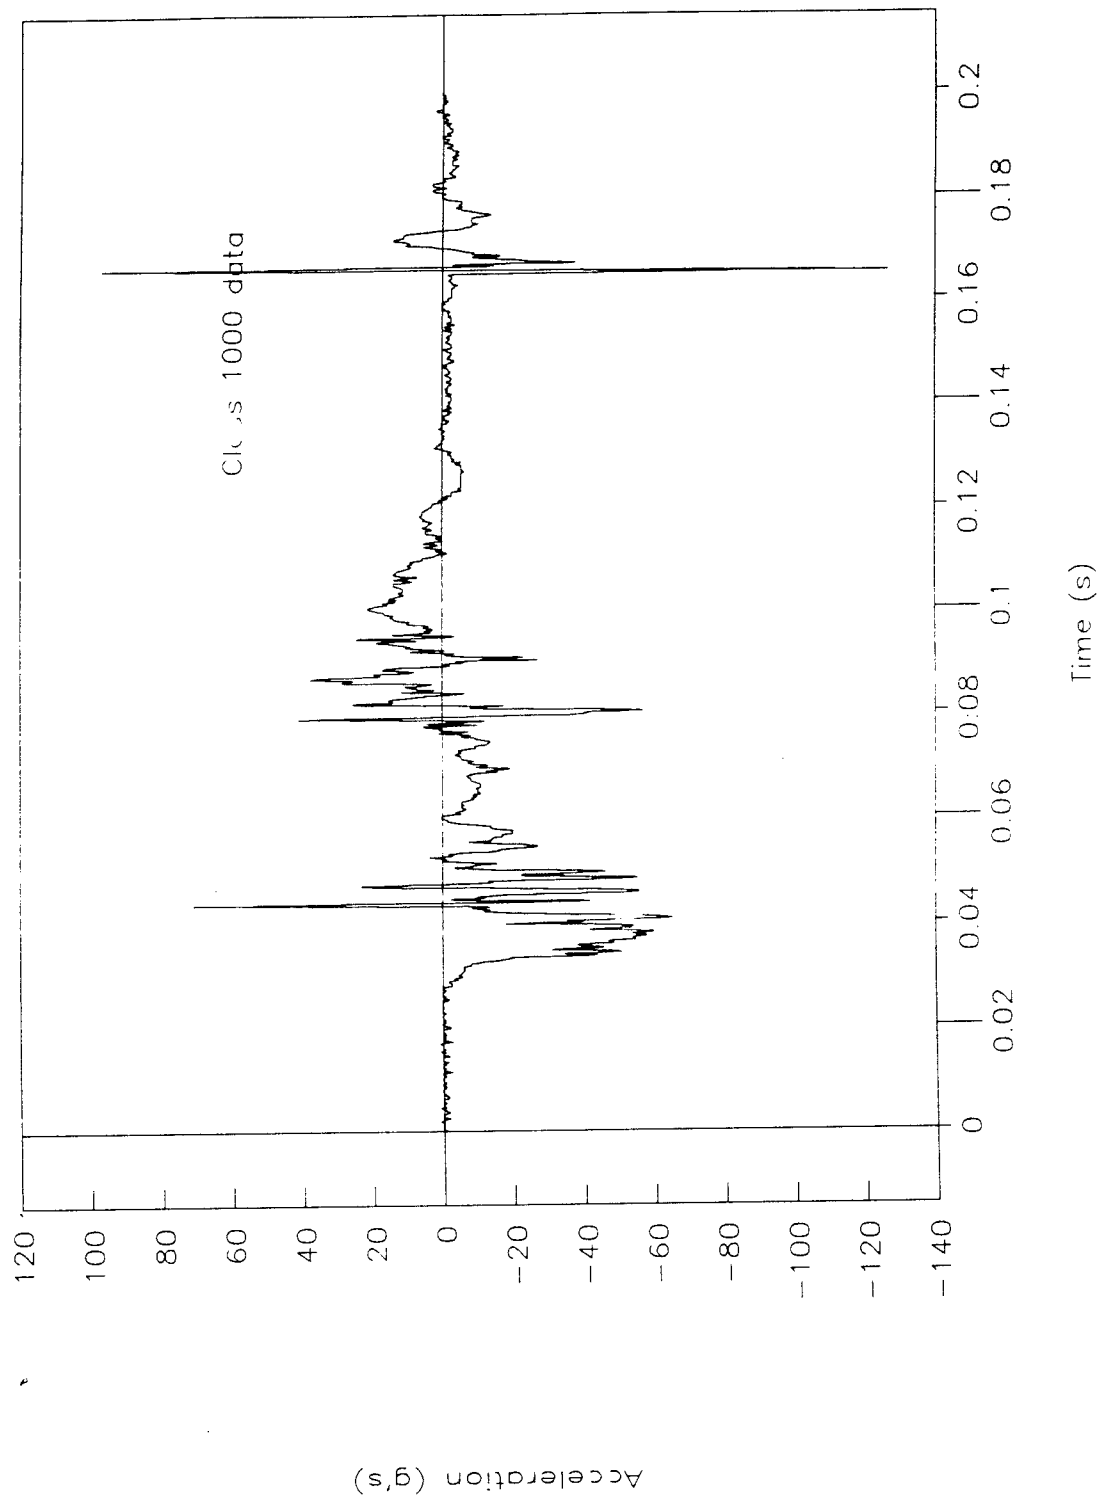
Figure 32. Acceleration vs. time, redundant lower rib, test 97S006.

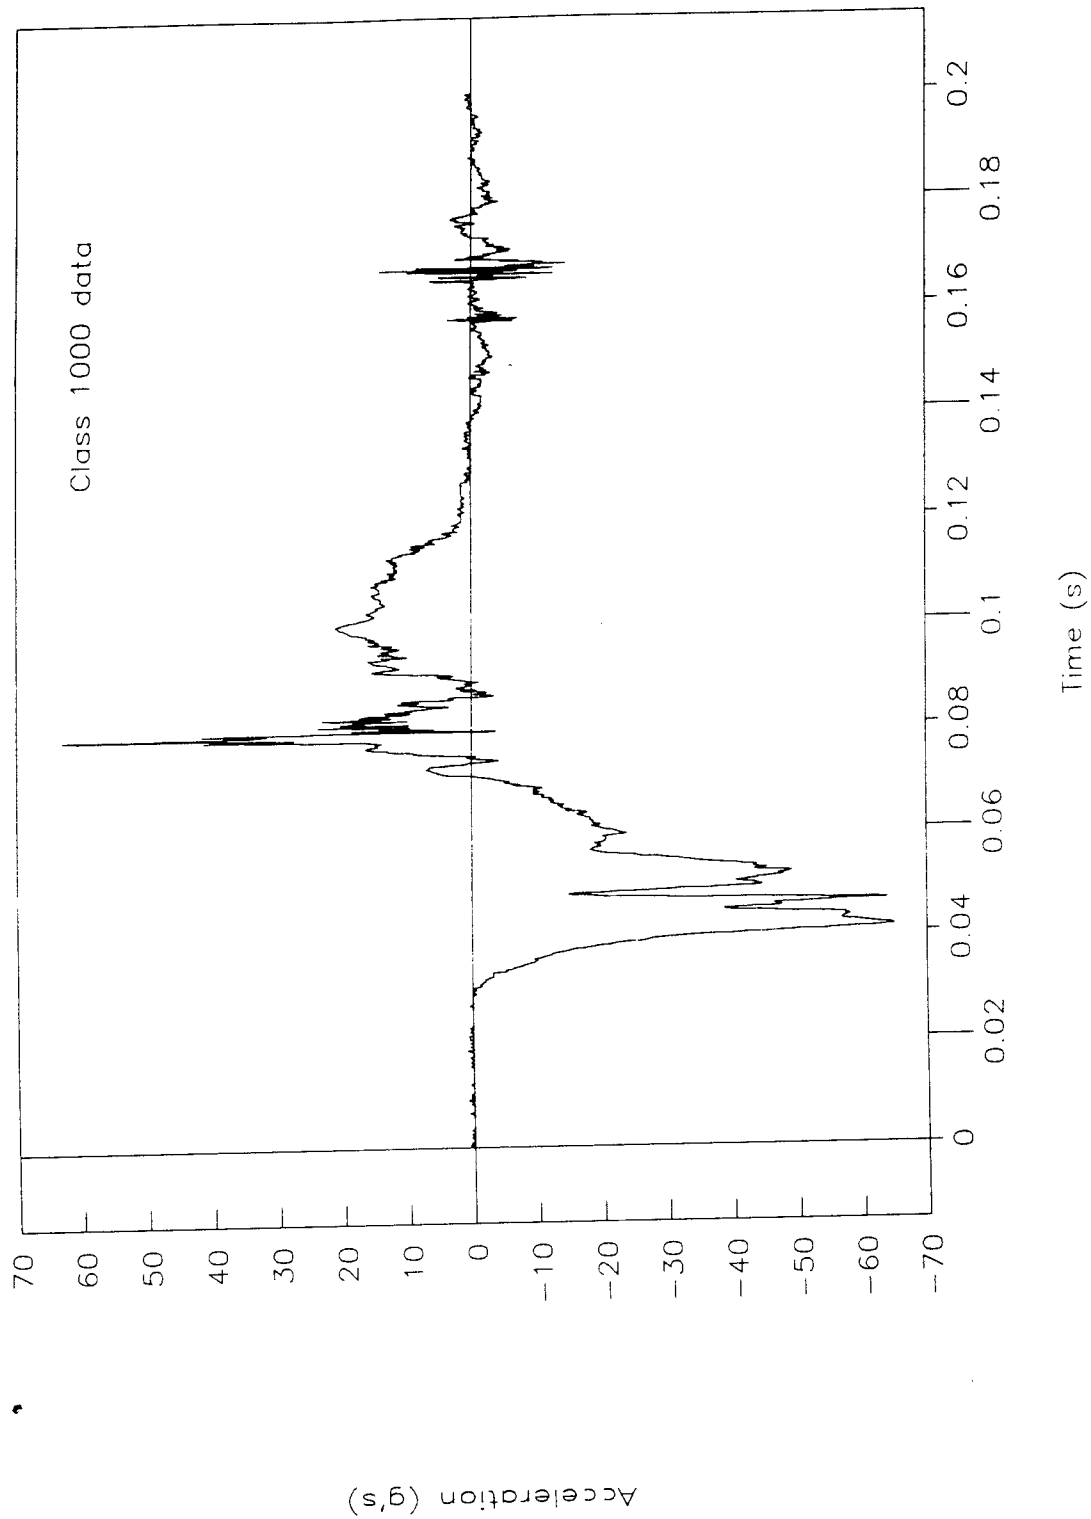
Figure 33. Acceleration vs. time, primary T12 spine, test 97S0006.

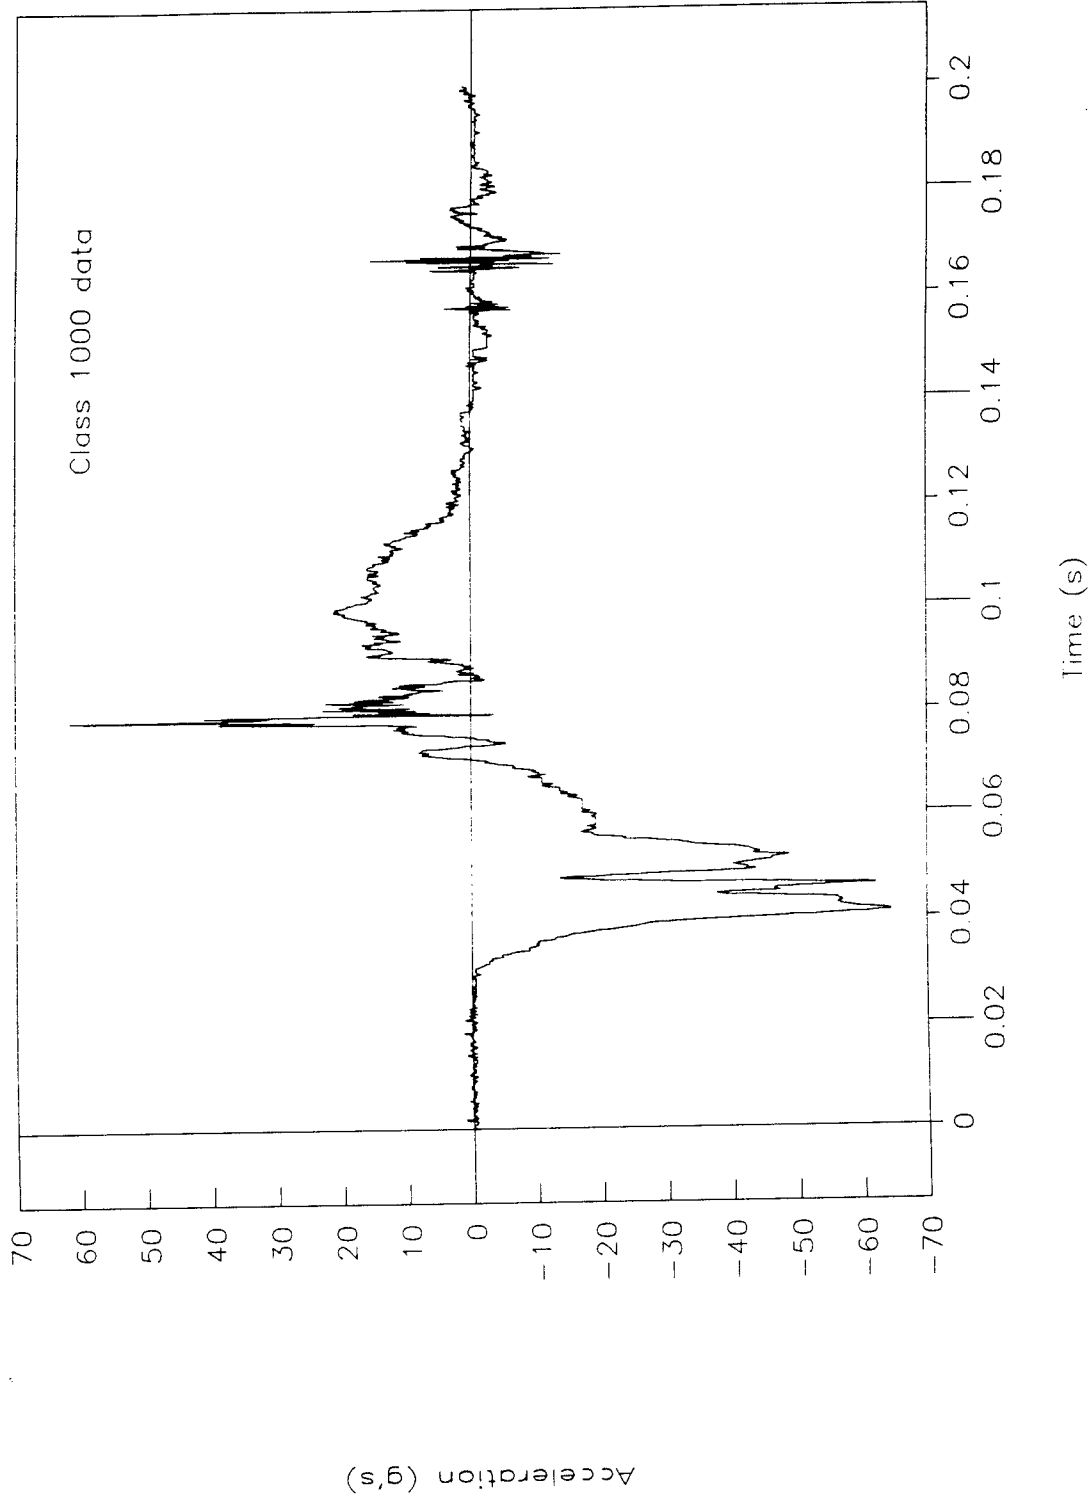
Figure 34. Acceleration vs. time, redundant T12 spine, test 97S0006.

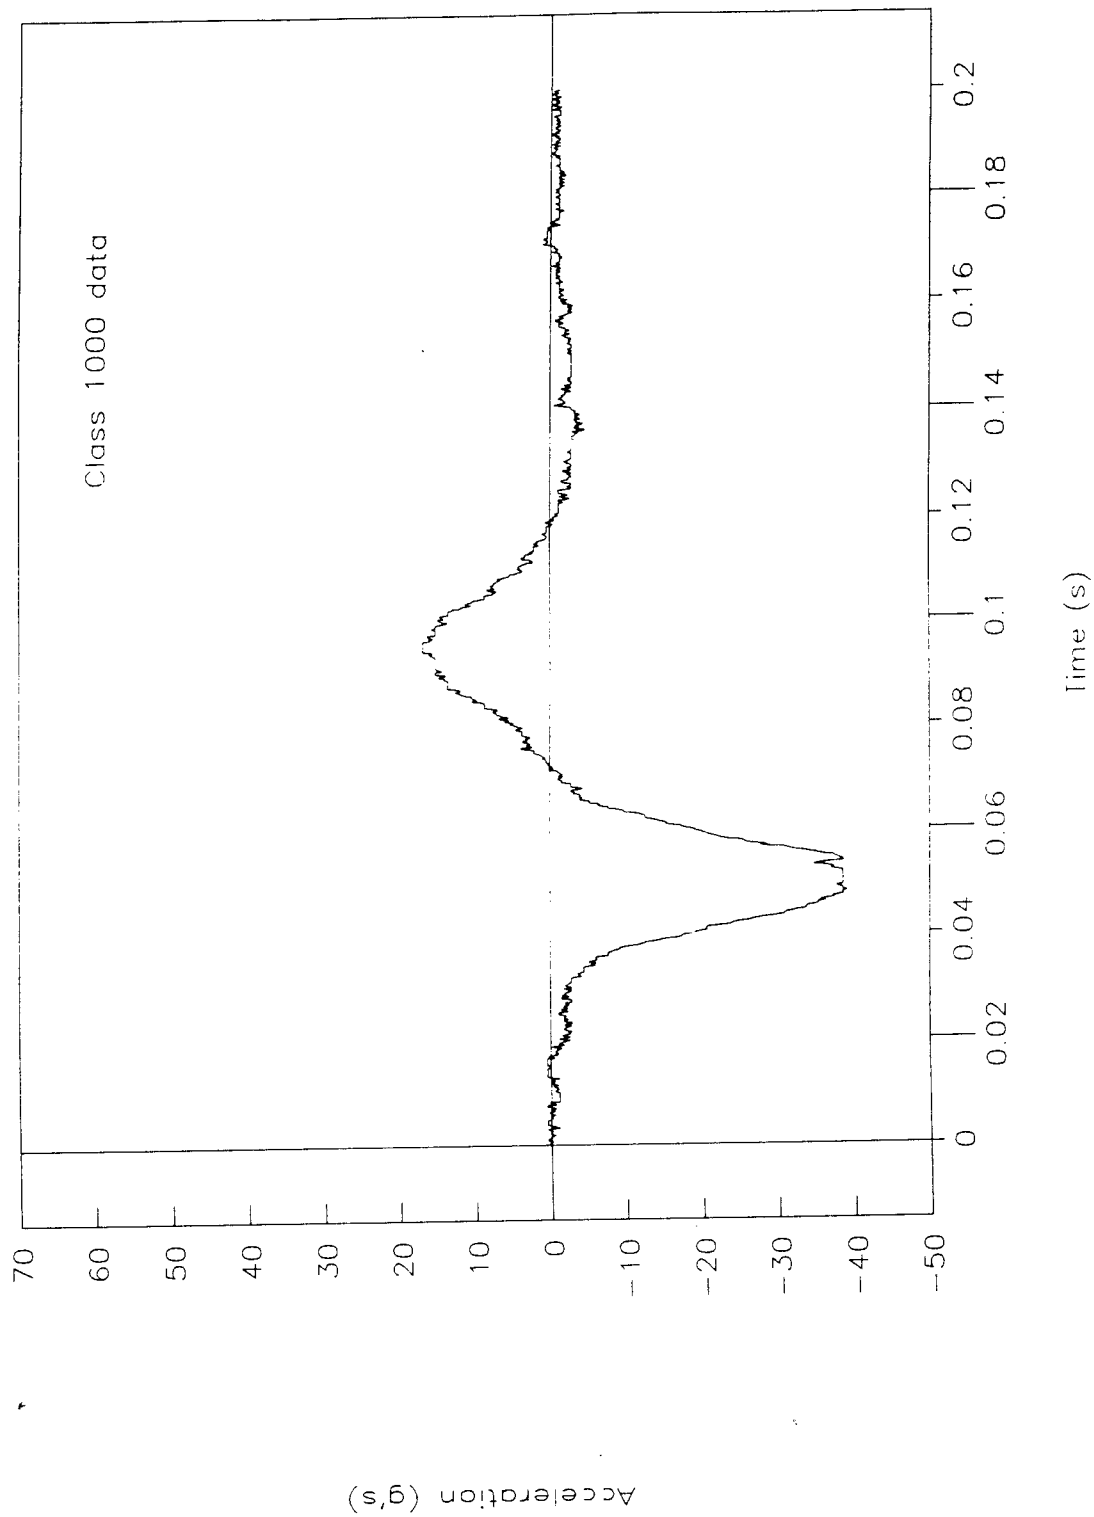
Figure 35. Acceleration vs. time, Y-axis pelvis, test 97S006.

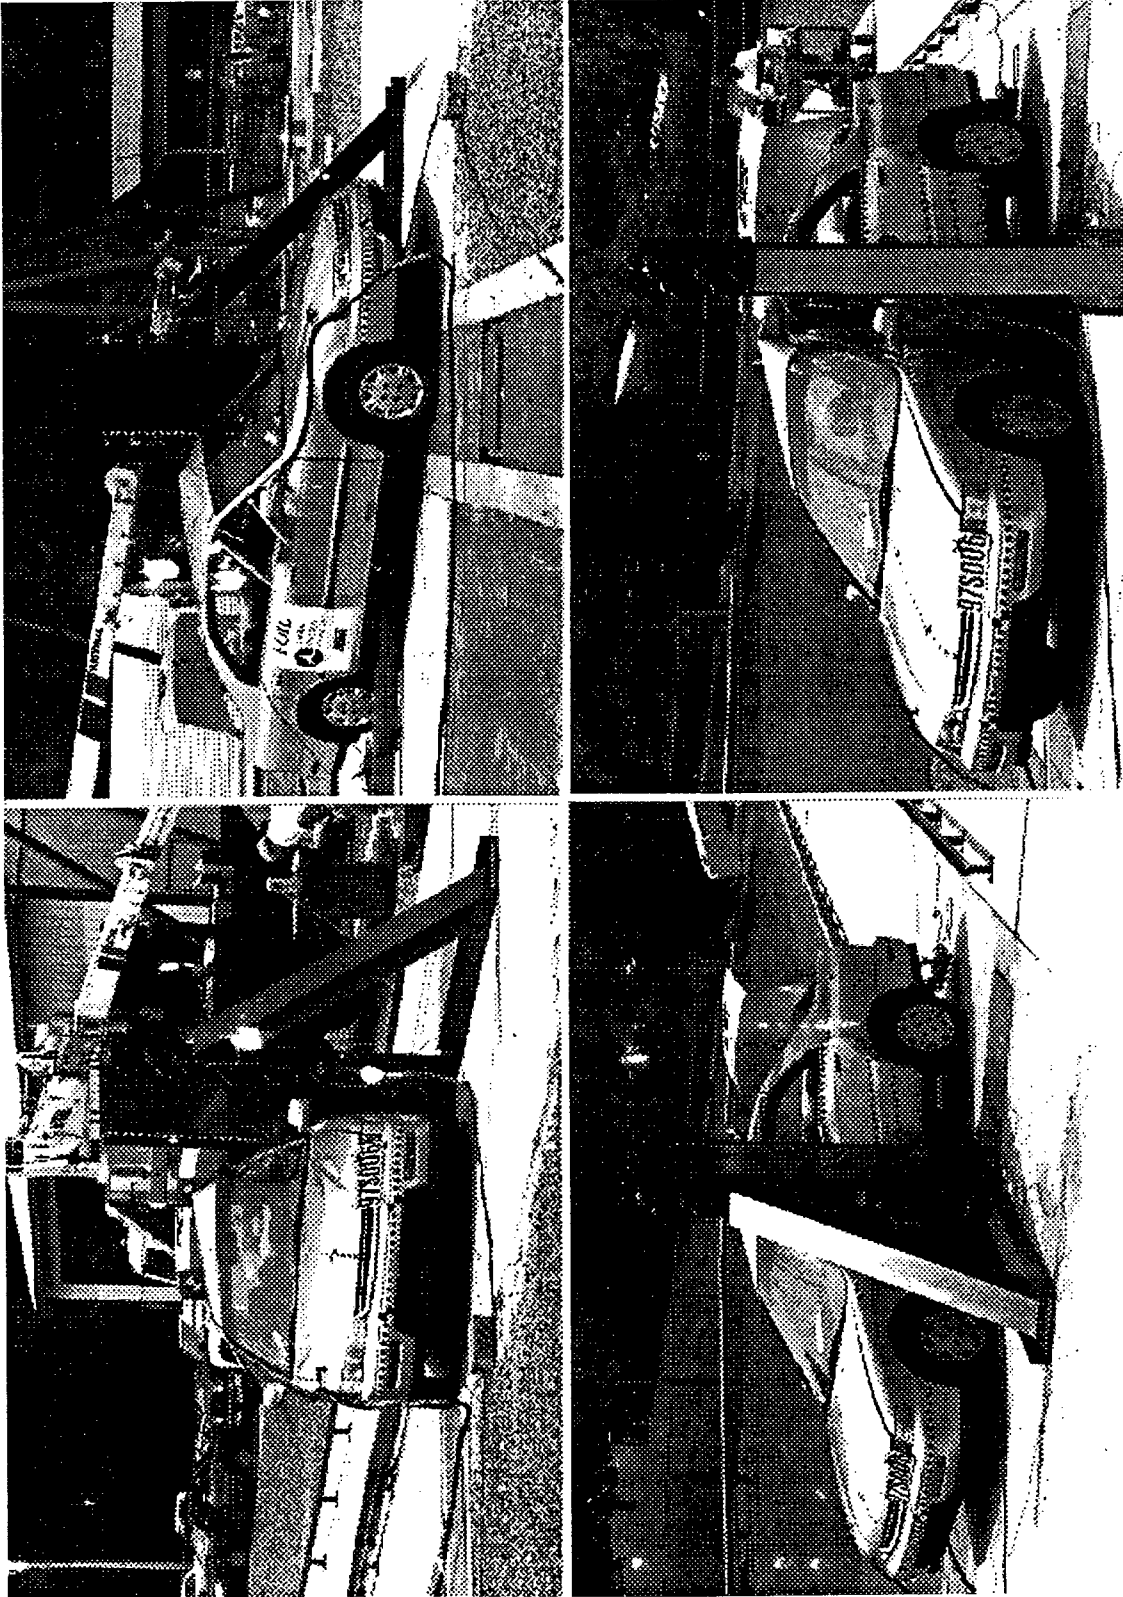
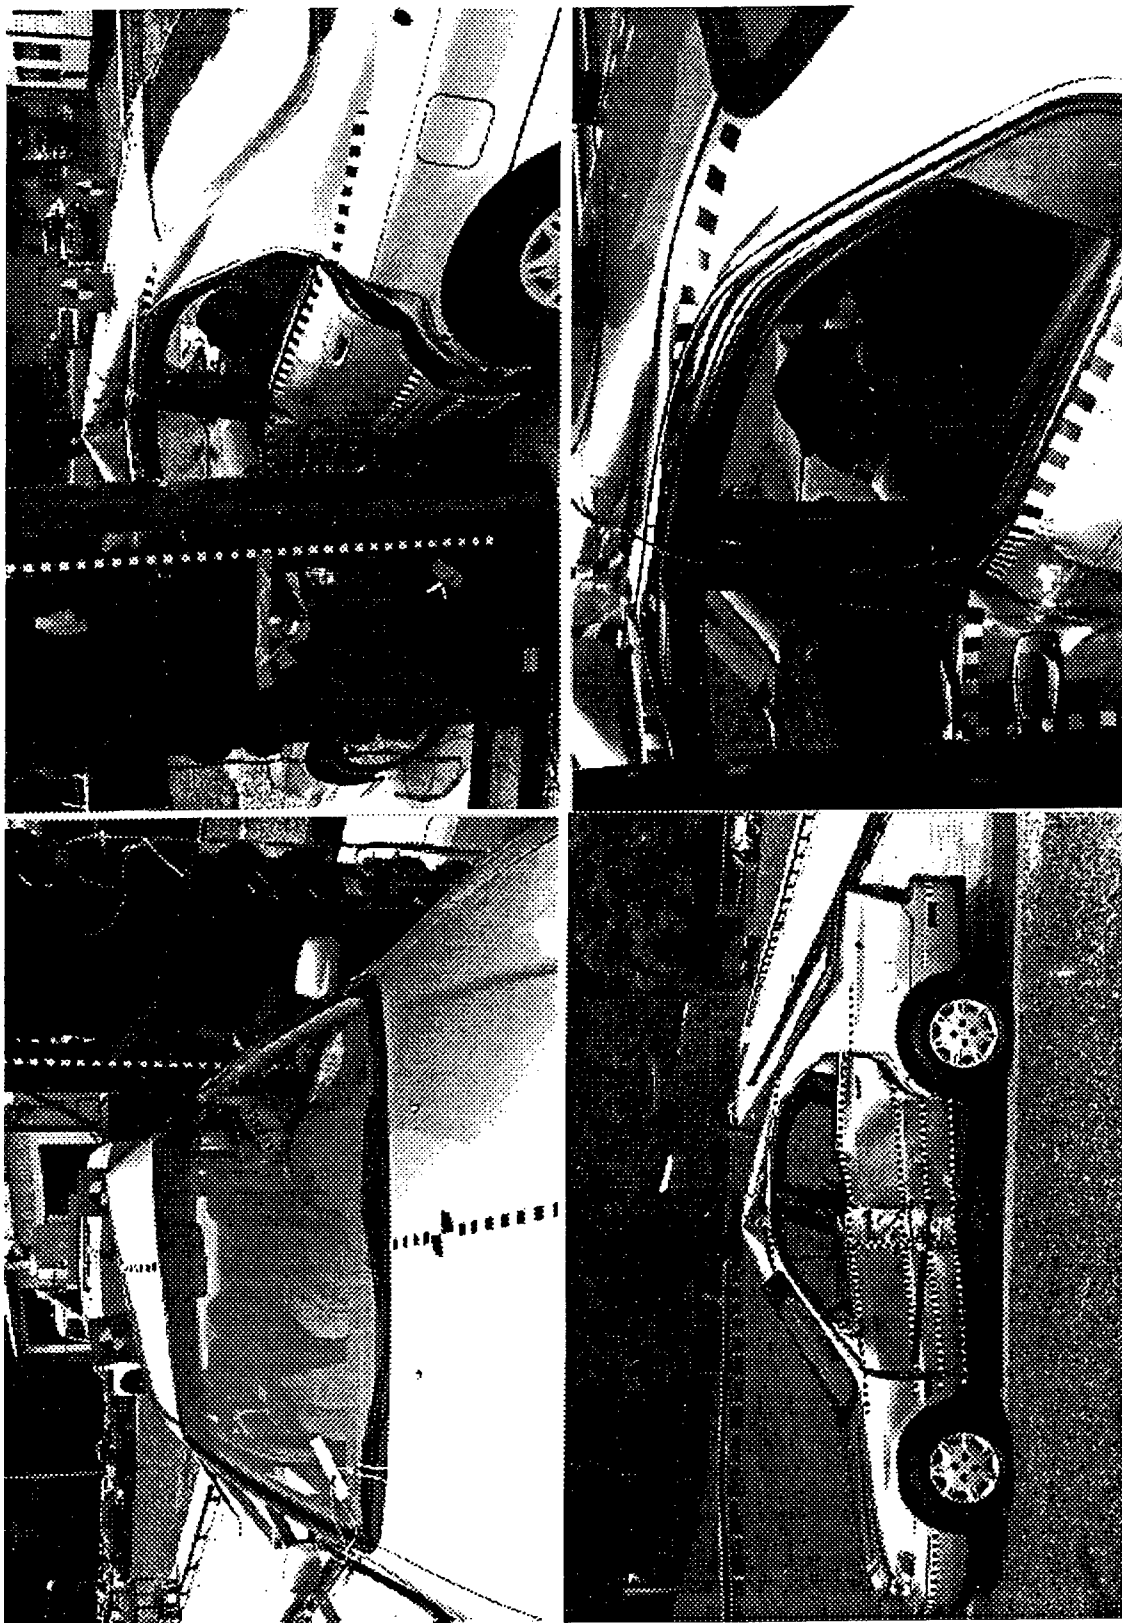
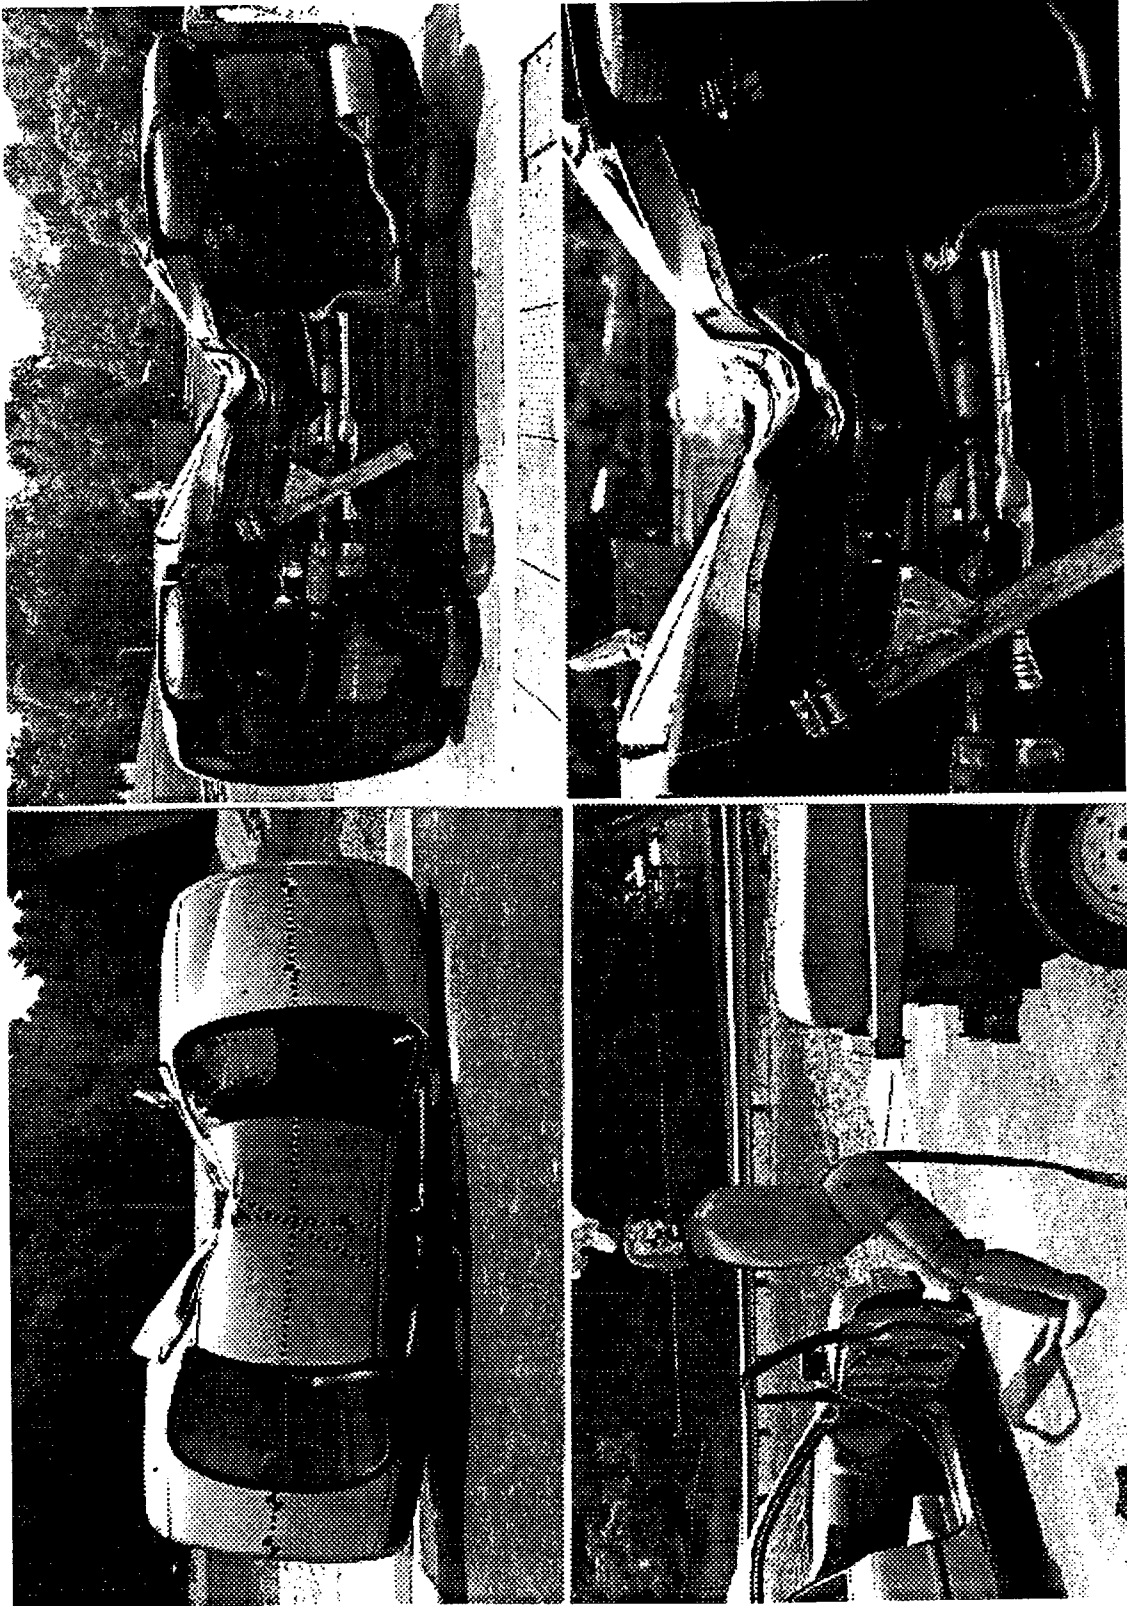
Figure 38. Post-test photographs, test 97S006.

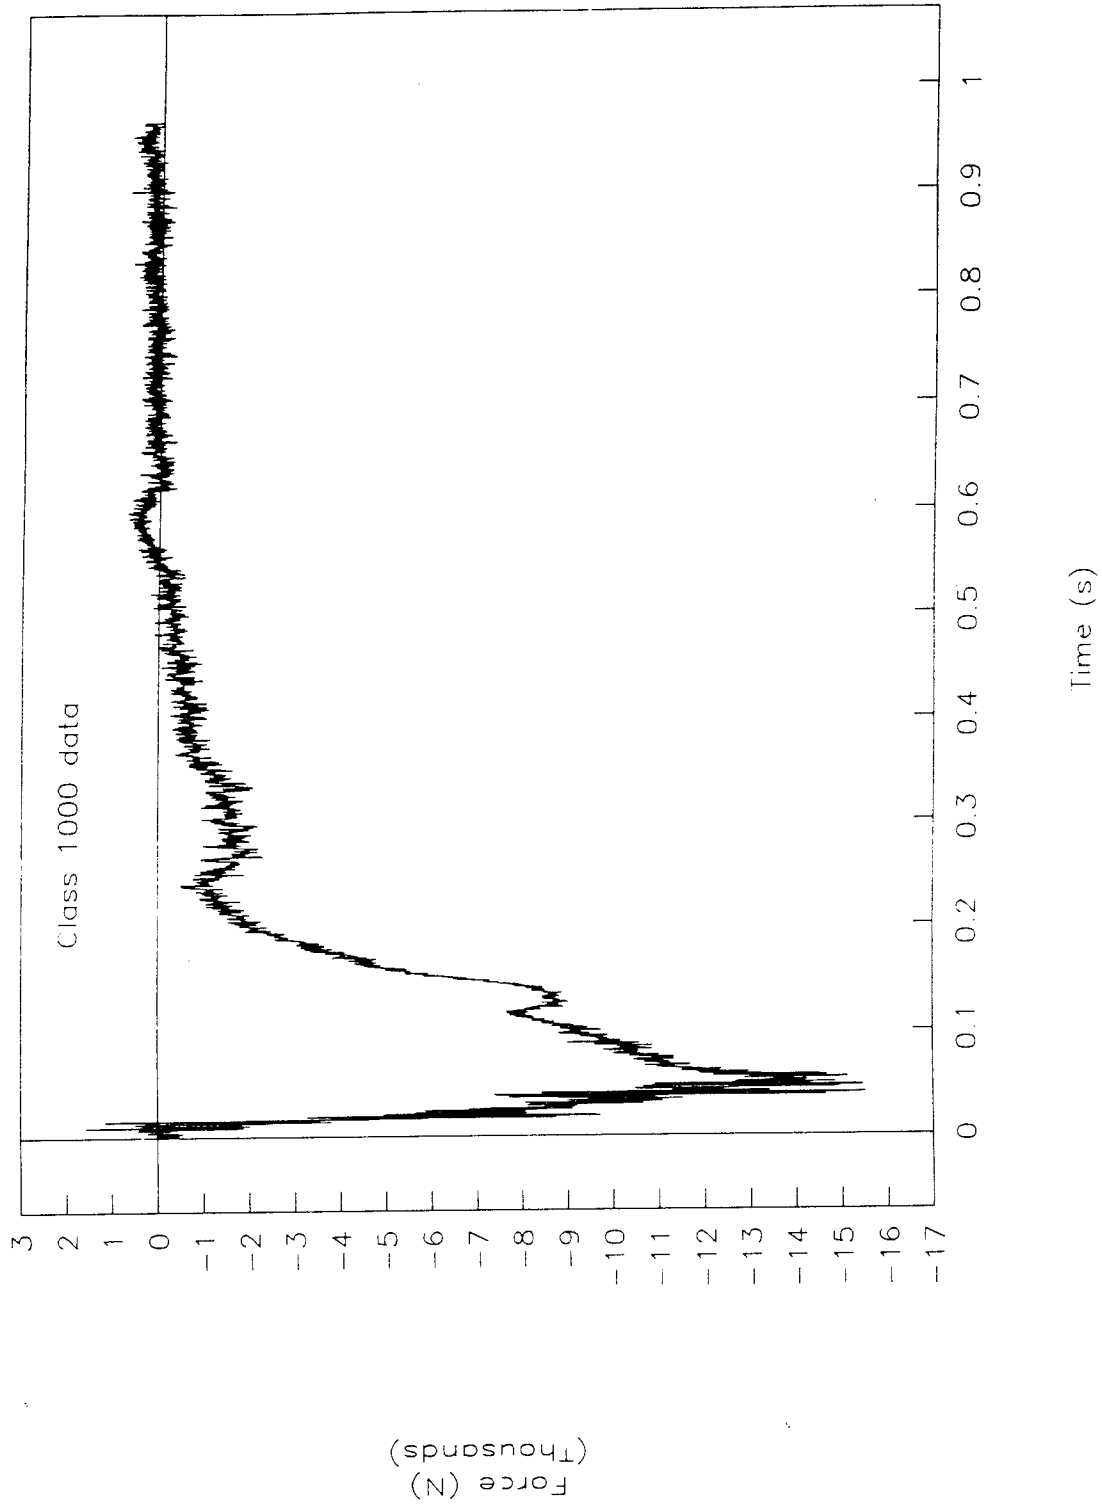
Figure 39. Rigid pole, force vs. time, bottom face lower load cell, test 97S006.

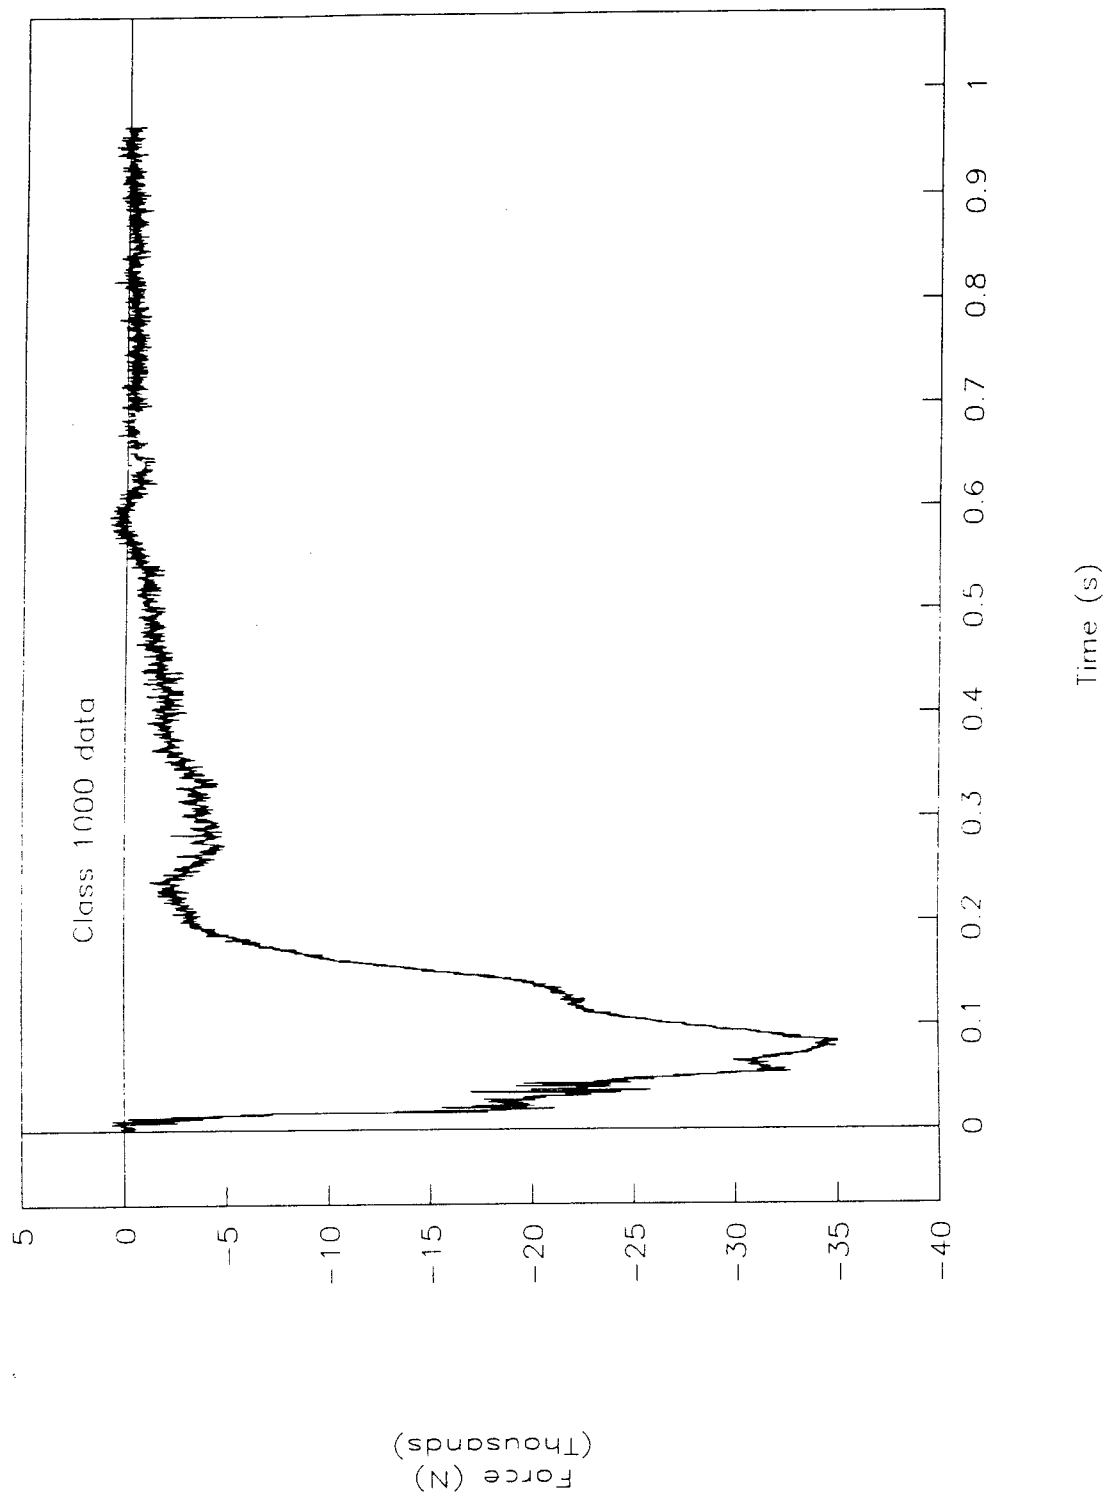
Figure 40. Rigid pole, force vs. time, bottom face upper load cell, test 97S006.

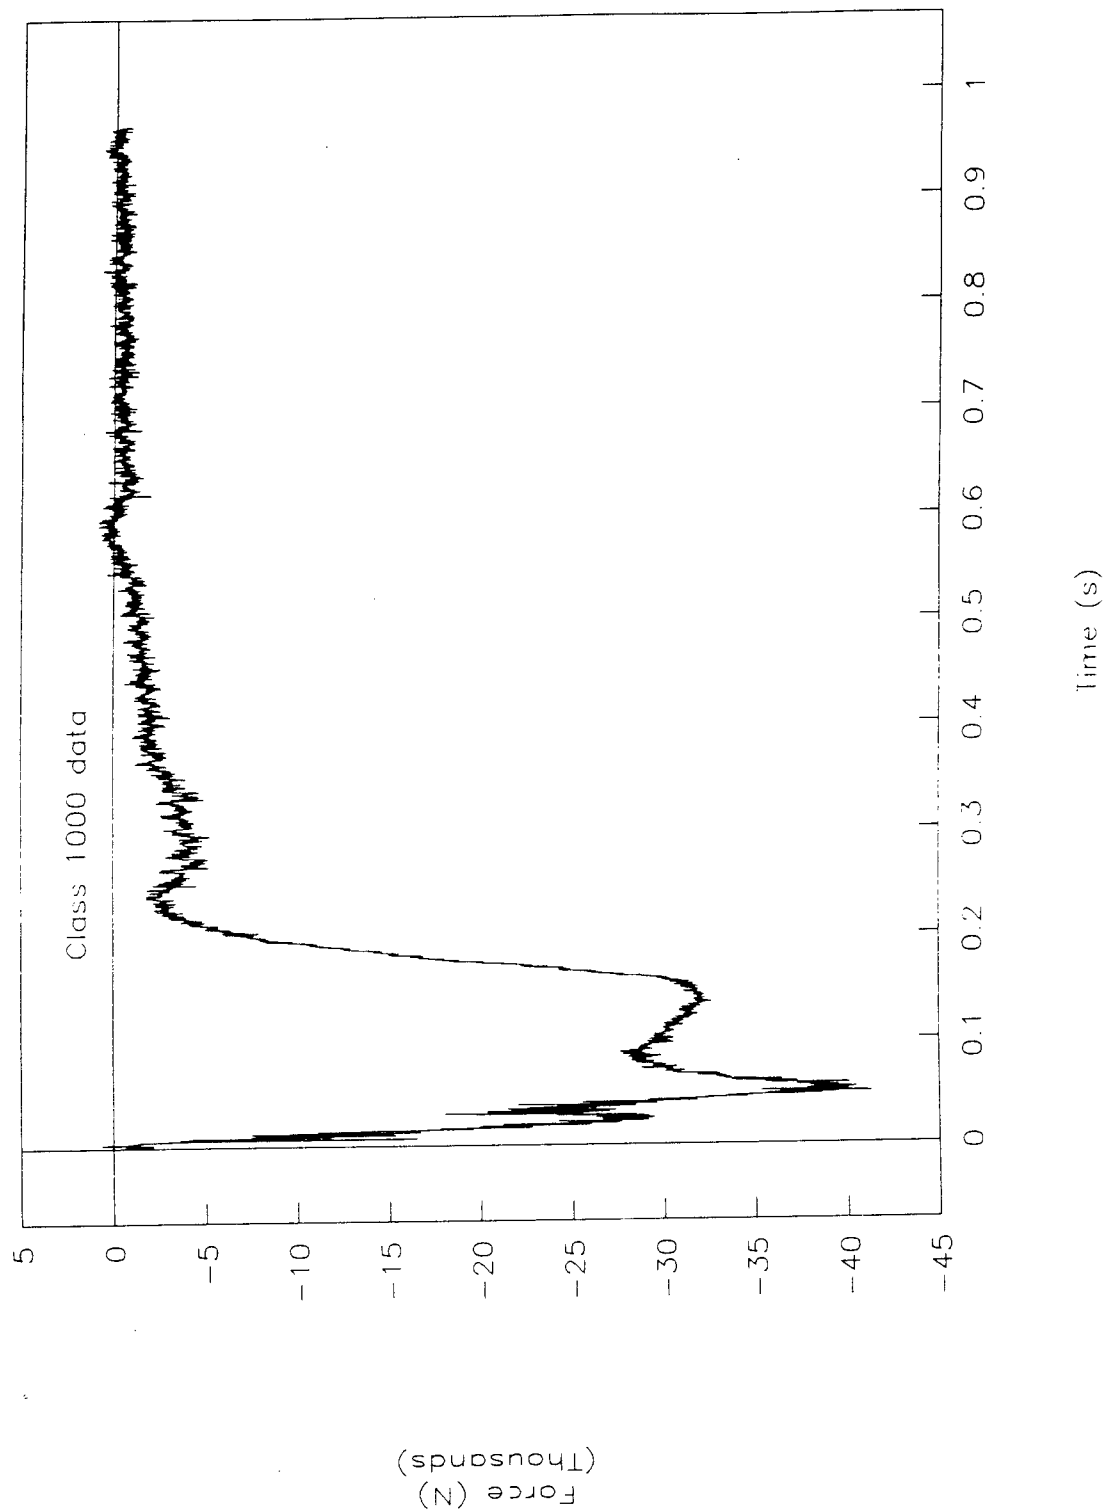
Figure 41. Rigid pole, force vs. time, lower-middle face lower load cell, test 97S006.

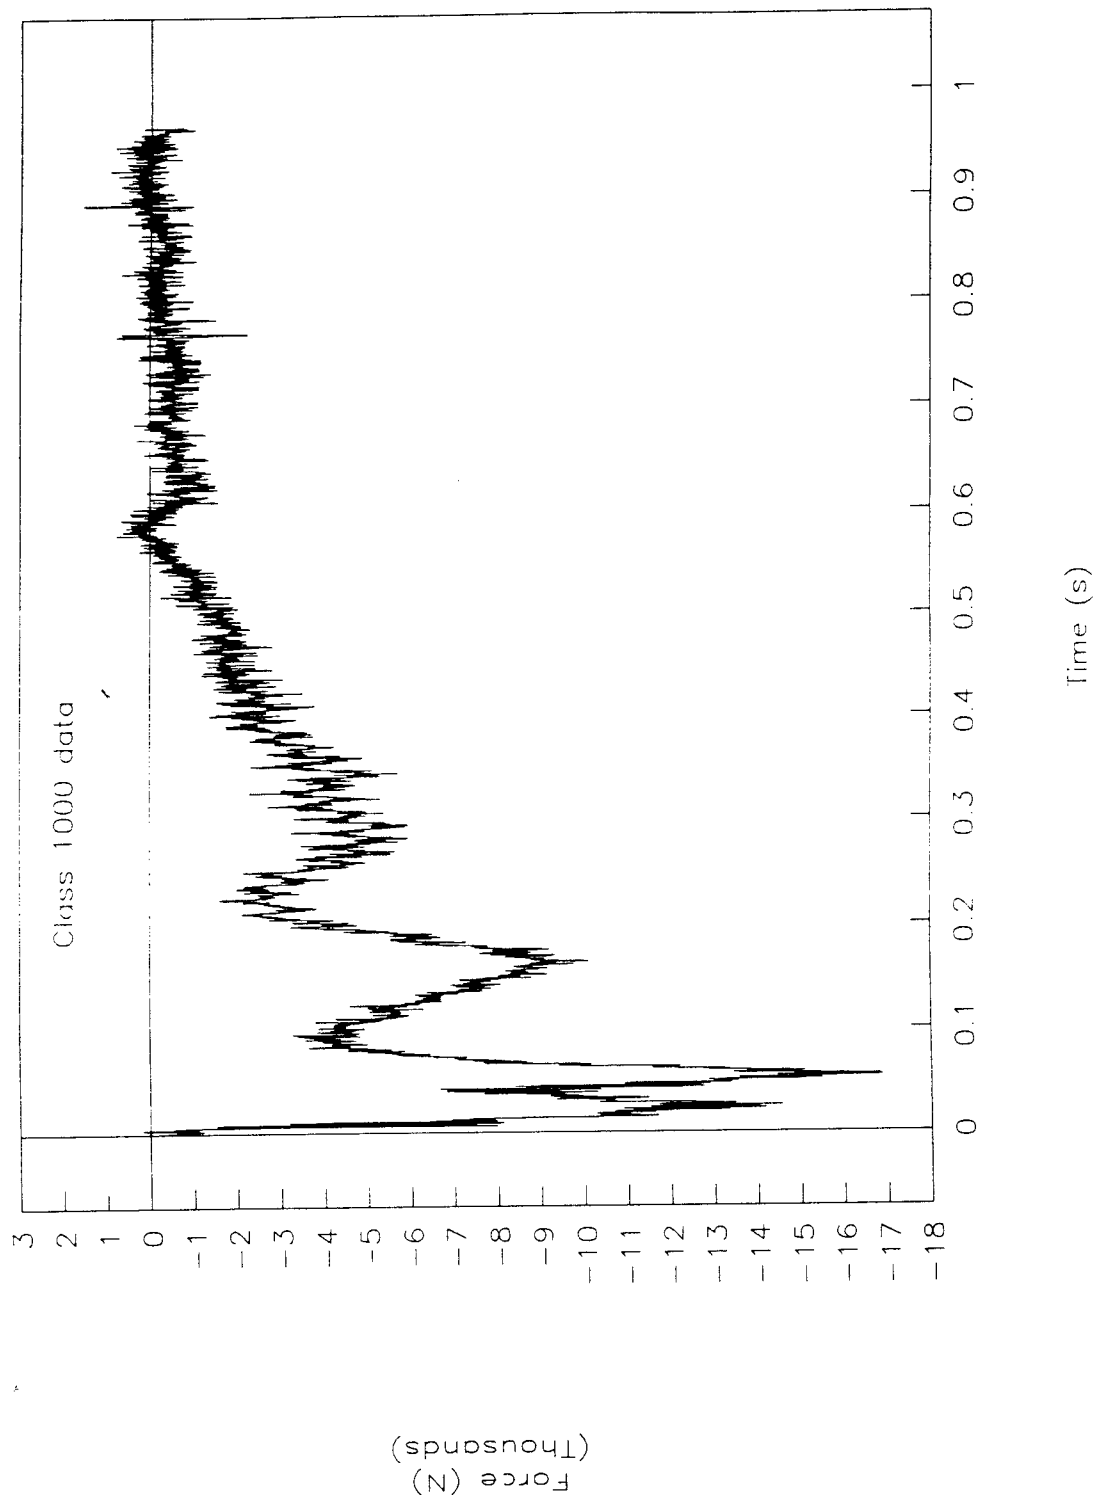
Figure 42. Rigid pole, force vs. time, lower-middle face upper load cell, test 97S006.
